Special Briefing by the Ministry of Defence of the Russian Federation on the crash of the Malaysian Boeing 777 in the Ukrainian air space, July 21, 2014

Speech of the Chief of the Main Operations Directorate – the Deputy Chief of the General Staff of the Armed Forces of the Russian Federation Lieutenant-General A.V.Kartapolov

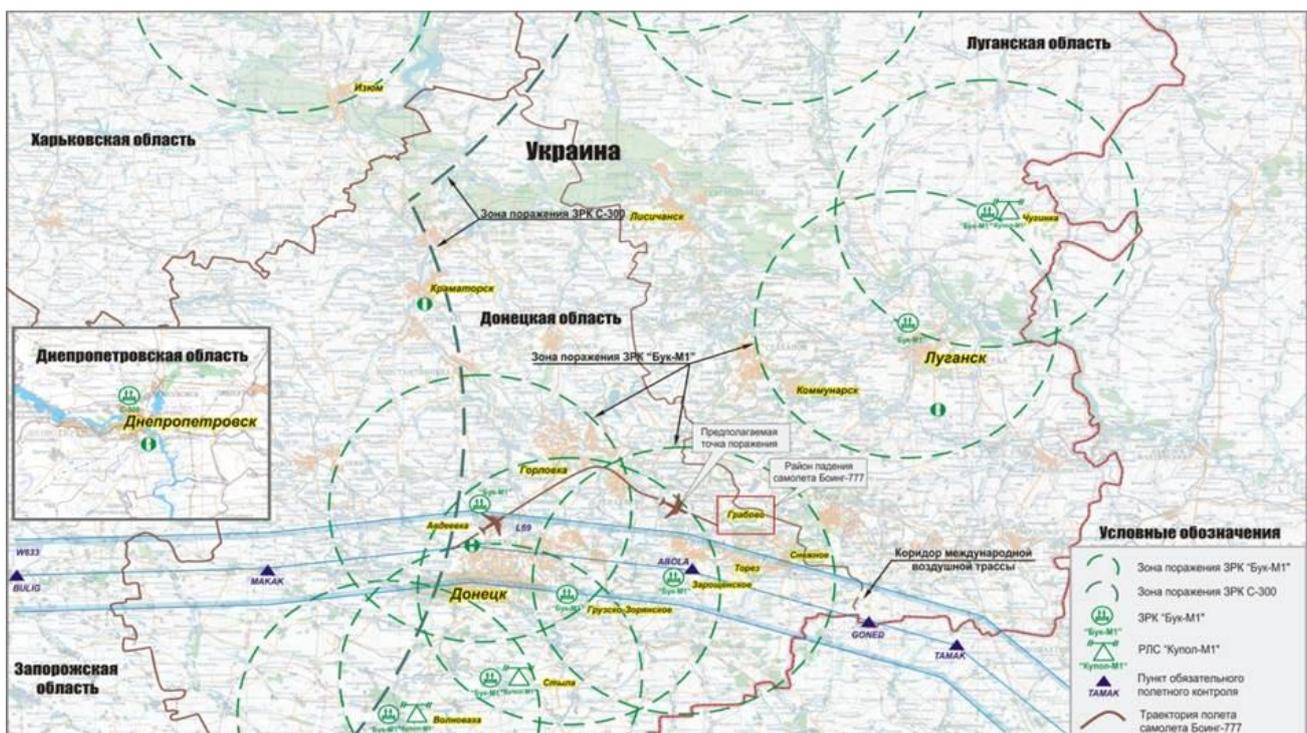
After the Malaysia Airlines Boeing-777 accident on July 17, following the international airway Amsterdam - Kuala Lumpur, we can find quantity of conflicted information. In this case the Russian Federation Ministry of Defense considers necessary to submit information having at the General Staff disposal. On the scheme you can see the international airway. The Boeing-777 was supposed to fly on this airway. Draw your attention to the fact that the aircraft followed inside the specified air-corridor to Donetsk, then it deviated from the route to north. Meanwhile the maximum distance from the left border of the air-corridor was 14 kilometers.

Then we can see that the Boeing-777 turned back to the borders of the specified air-corridor. Nevertheless Malaysian aircrew didn't succeed the maneuver. At 17.20 we entered the event of the aircraft rate reduction, at 17.23 the aircraft's point blinked off on the radar. Why did the aircraft cross the border of the air-corridor? Was it the navigation mistake, or the aircrew followed the Dnepropetrovsk ground control orders? We will find the answers after "black boxes" and communication decoding. According to our information on the day of the accident the Ukrainian Armed Forces deployed 3 to 4 artillery battalions of Buk-M1 missile system not far from Donetsk. The system allows hitting the targets on the distance up to 35 kilometers and on the altitude to 22 kilometers. Why did the Ukrainian Armed Forces deploy these air defense units in the Donetsk region? As we know militants don't have aircrafts. On the scheme we can see that both projected impact point and the airway are inside the air defense battle zone of the Ukrainian Armed Forces' Buk-M1 missile

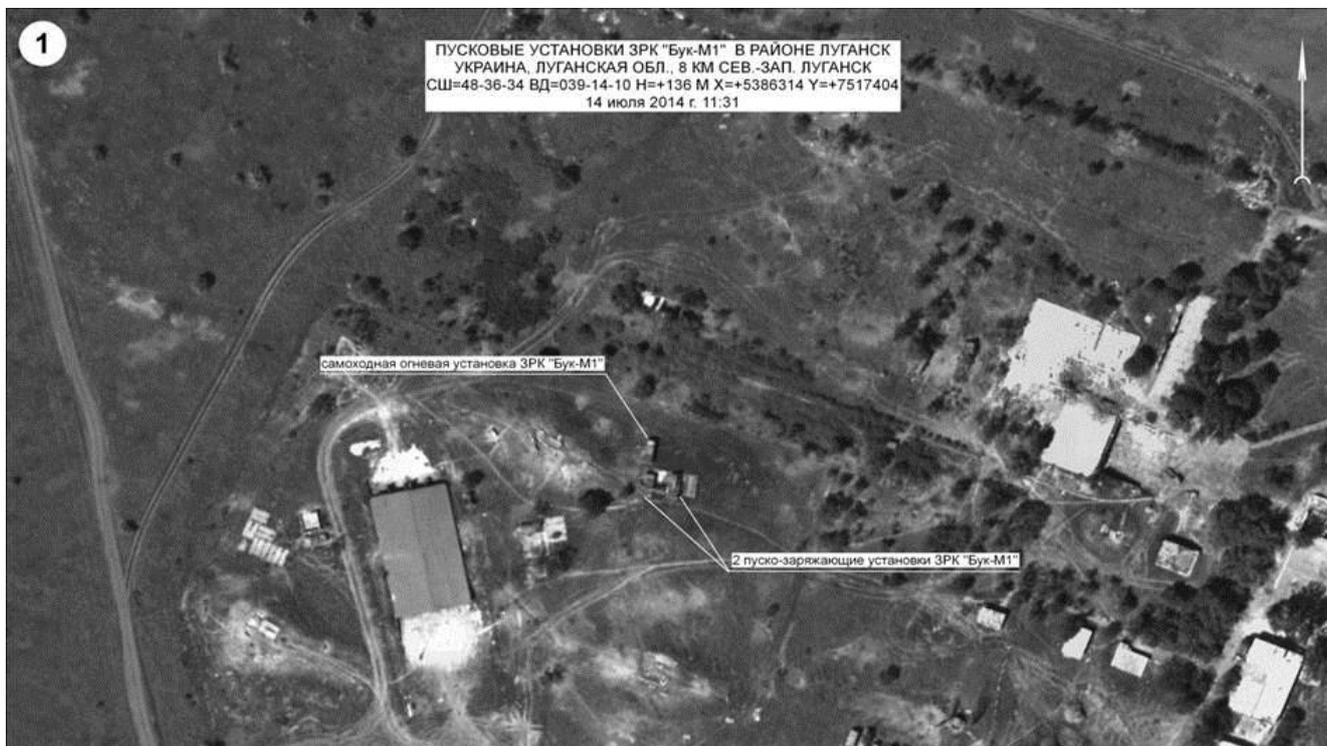
On the first photo you can see the Buk missile systems deployed 8 kilometers north-west to Luhansk. On the photo you can see clearly a self-propelled launch system and 2 loading vehicles.

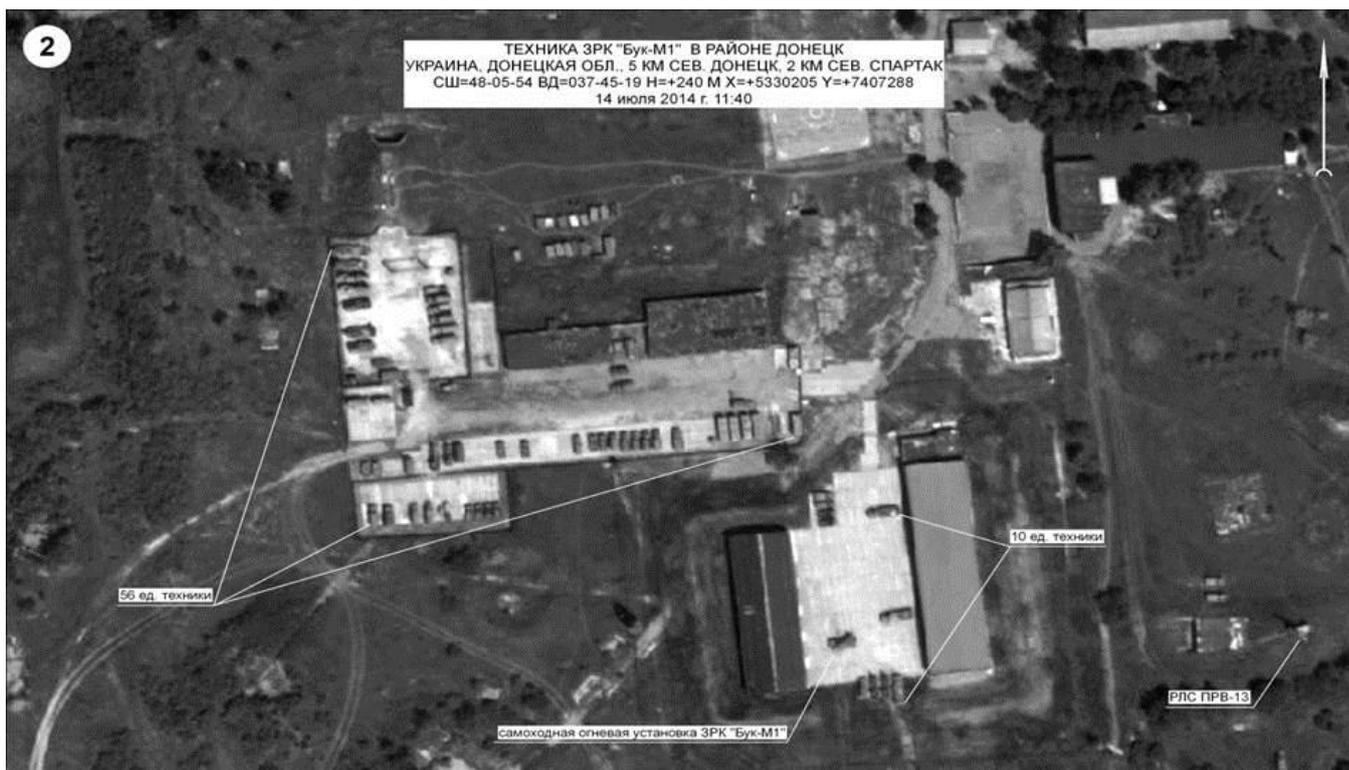
On the second photo you can see radars deployed 5 kilometers north to Donetsk. We can see 2 radars, different equipment and facilities.

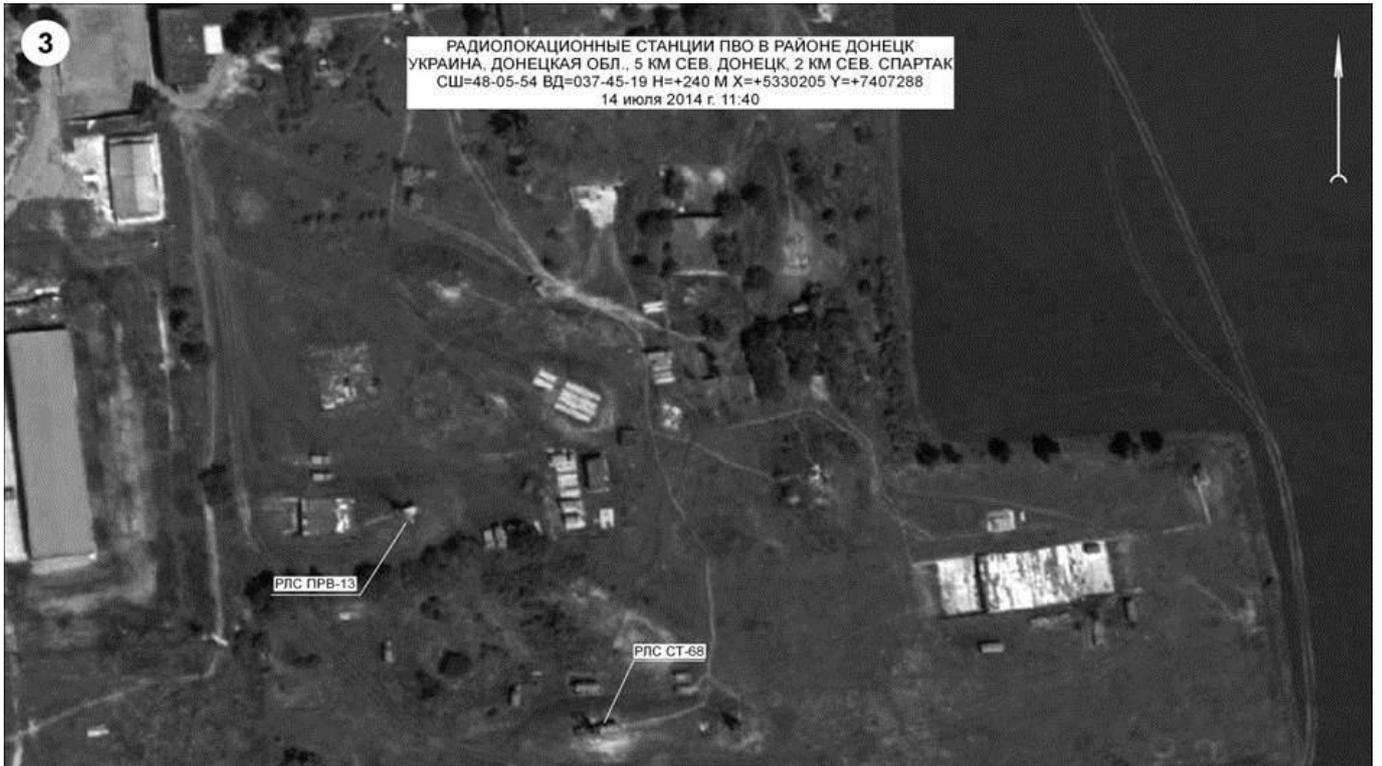
On the third photo we can see air defense equipment deployed north to Donetsk. You can see clearly self-propelled launch system with turned launch shoe and near 60 units of military and special-proposed equipment, mounted defilades and facilities.

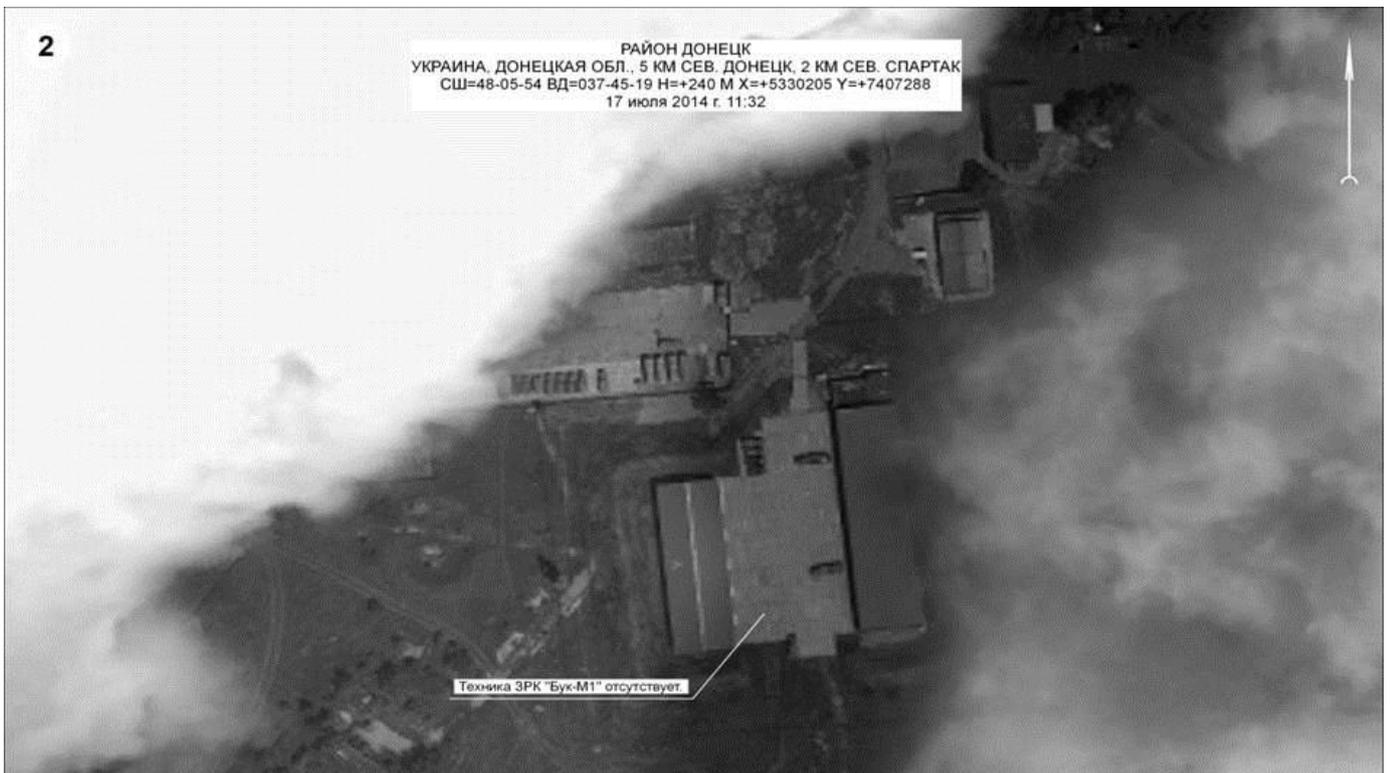
Here you can see a photo of the same area on July 17. Draw your attention that the anti-aircraft system is absent on this photo.

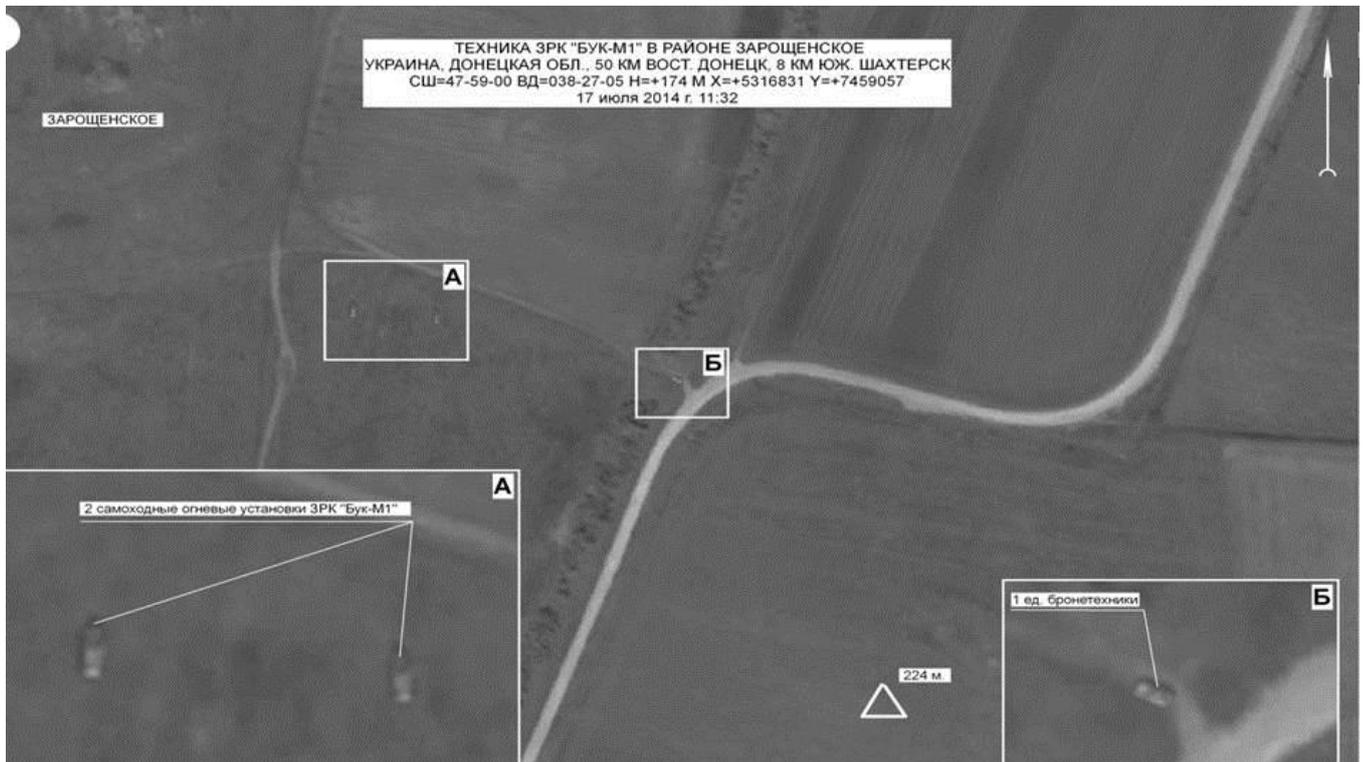
On the fifth photo we can see Buk-M1 artillery battalion deployed 50 kilometers east to Donetsk and 8 kilometers south to Shakhtarsk. We can answer: why the battalion was deployed near to the territory controlled by militants just before the accident?

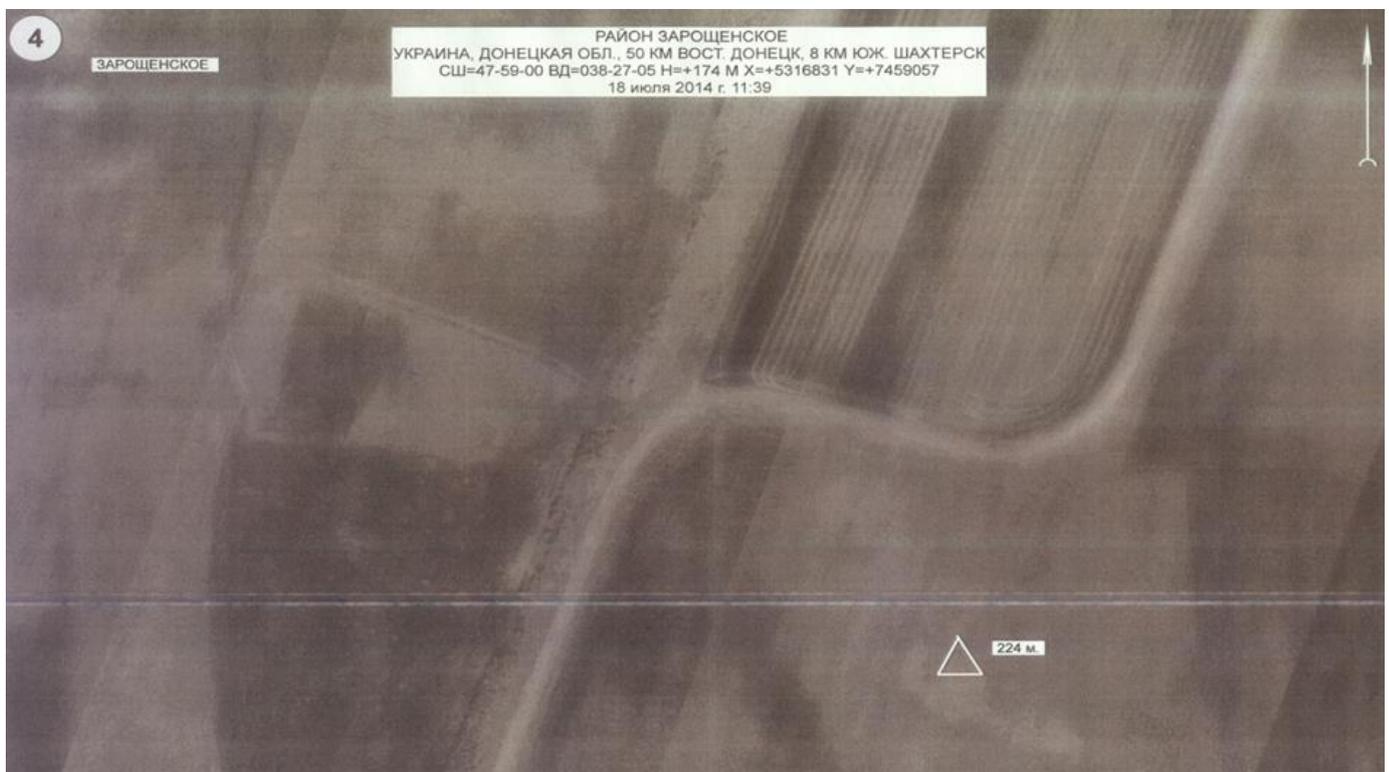
On the photo of same area dated July 18 we can see that the battery left the occupied position. Besides it, on July 17 we detected increased activity of Ukrainian radars 9S18 Kupol-M1 of the Buk missile system.

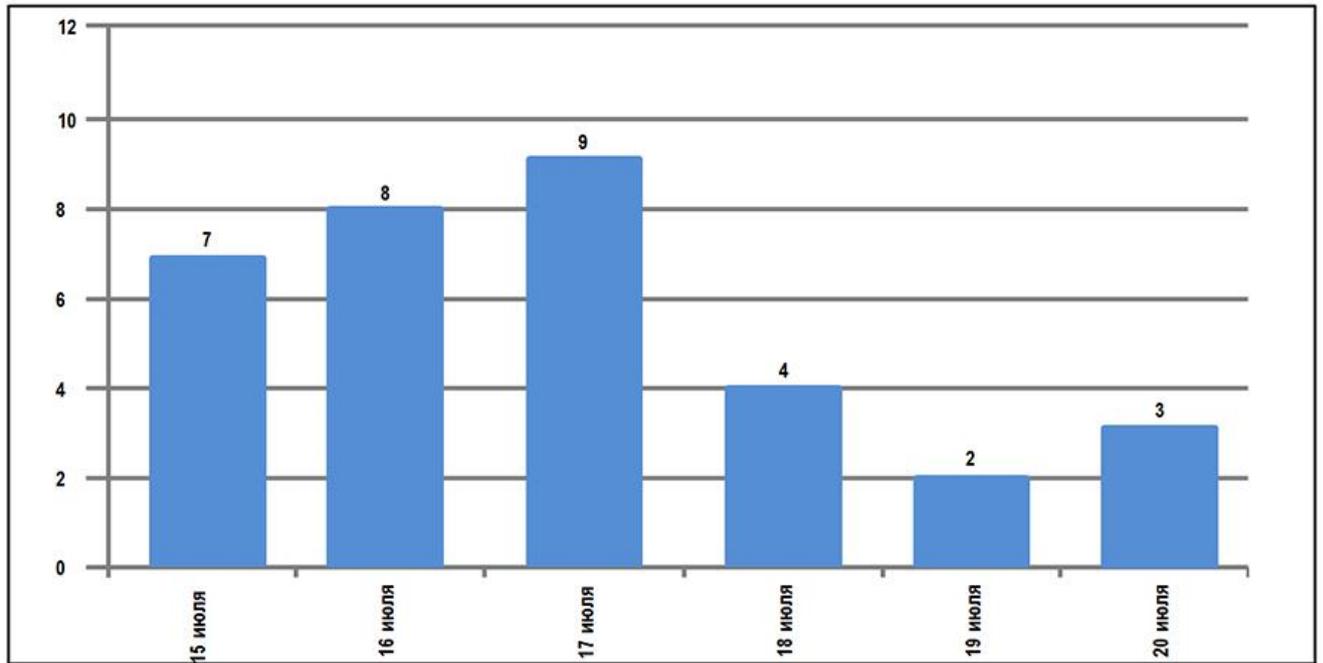
СТАТИСТИЧЕСКИЕ ДАННЫЕ О КОЛИЧЕСТВЕ ФУНКЦИОНИРУЮЩИХ РЛС «КУПОЛ» С 15 ПО 20 ИЮЛЯ 2014 Г.

On the photo you can see that 7 radars worked on July 15, 8 radars on July 16, and 9 radars on July 17. Since July 18 there are only 2-3 radars per twenty-four hours. We shall find out the reasons for the events.

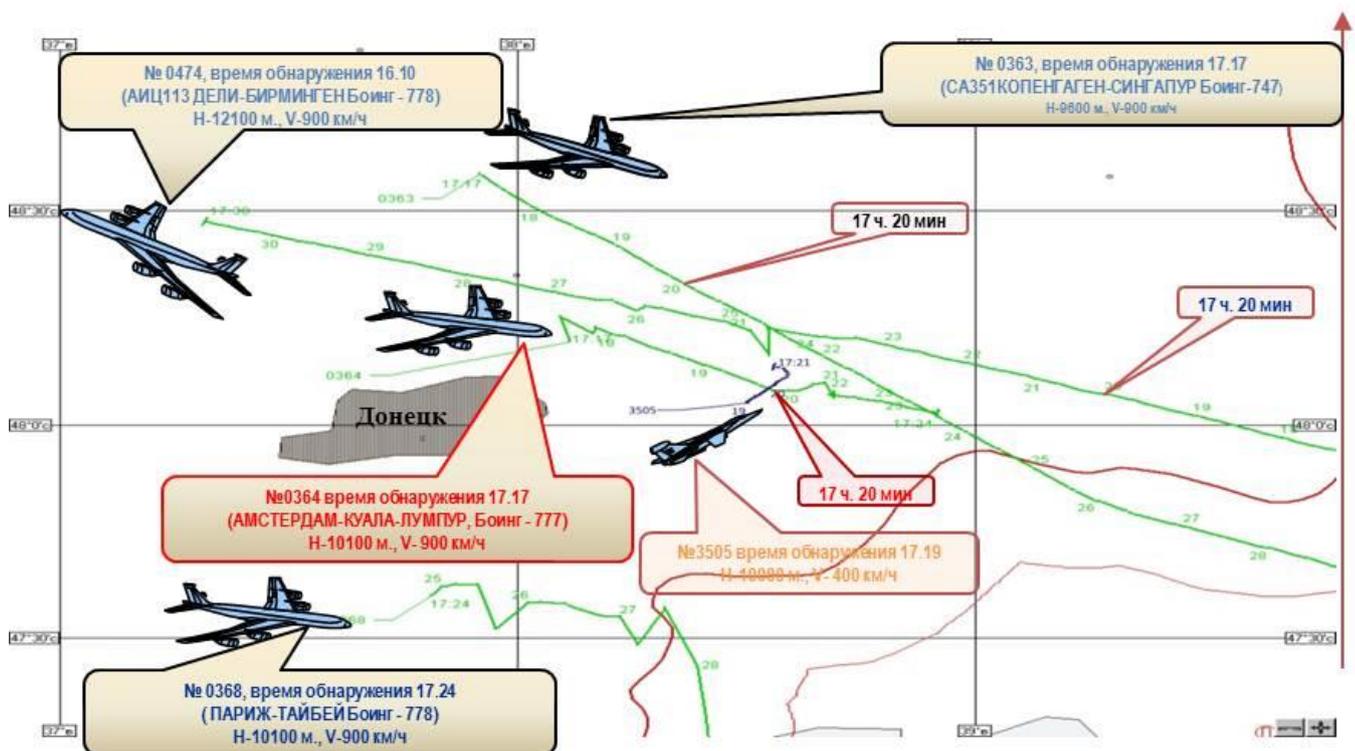
I want to expose air situation in Donetsk area that day. On the picture you can see information of objective control since 17.10 to 17.30 Moscow time.

At that time there were 3 civilian aircrafts:

Flight from Copenhagen to Singapore at 17.17;

Flight from Paris to Taipei at 17.24

Flight from Amsterdam to Kuala Lumpur.

Besides it, Russian system of air control detected the Ukrainian Air Force aircraft, purposed Su-25, moving upwards toward to the Malaysian Boeing-777. The distance between aircrafts was 3-5 kilometers.
